Professional Property Inspections and Much More...

## Condensation in Double-Paned Windows

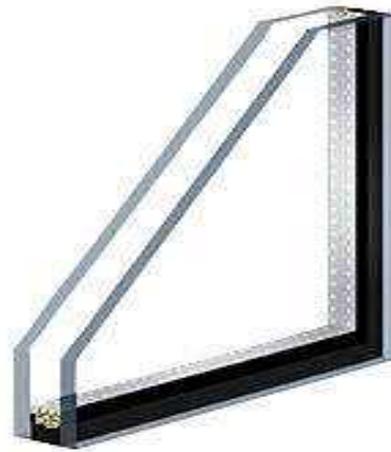
Double-pane or “thermal” windows are constructed with a quantity of gas (usually argon) that is trapped between the two panes of glass. This trapped air acts as insulation to reduce heat loss through the window. Some windows may also have a thin film installed between the panes, further reducing heat loss / gain through the window. If multiple-pane windows appear misty or foggy, it usually means that the seal protecting the window assembly has failed.

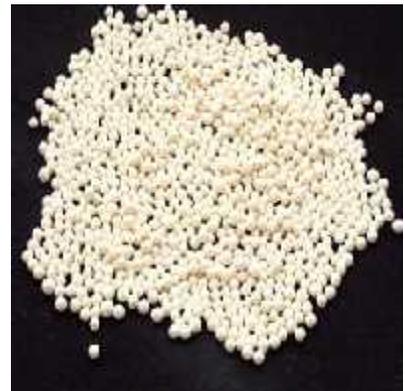
Silica desiccant is an absorbent material that is designed to prevent moisture accumulation. In a double-paned window, silica pellets inside an aluminum strip at the perimeter of the window frame absorb moisture of any incoming air that enters the space between the panes

As the seal or sealant (sometimes referred to as the “Thermal Seal”) of a window frame begins to fail, moist air enters the space between the panes, and the silica pellets (or “Desiccant Strips”) become saturated. Eventually, the pellets or strips are unable to prevent the accumulation of condensation. This results in condensation buildup between the glass panes.
